Docket No. 217 – Development and Management Plan Inspection

Northeast Utilities Service Company Certificate of Environmental Compatibility and Public Need for the construction of a 345-kV electric transmission line and reconstruction of an existing 115-kV electric transmission line between Connecticut Light and Power Company's Plumtree Substation in Bethel, through the towns of Redding, Weston, and Wilton, and to the Norwalk Substation in Norwalk, Connecticut.

Date: November 23, 2005

Location: Transition Stations: Hoyts Hill, Archers Lane, Norwalk Junction

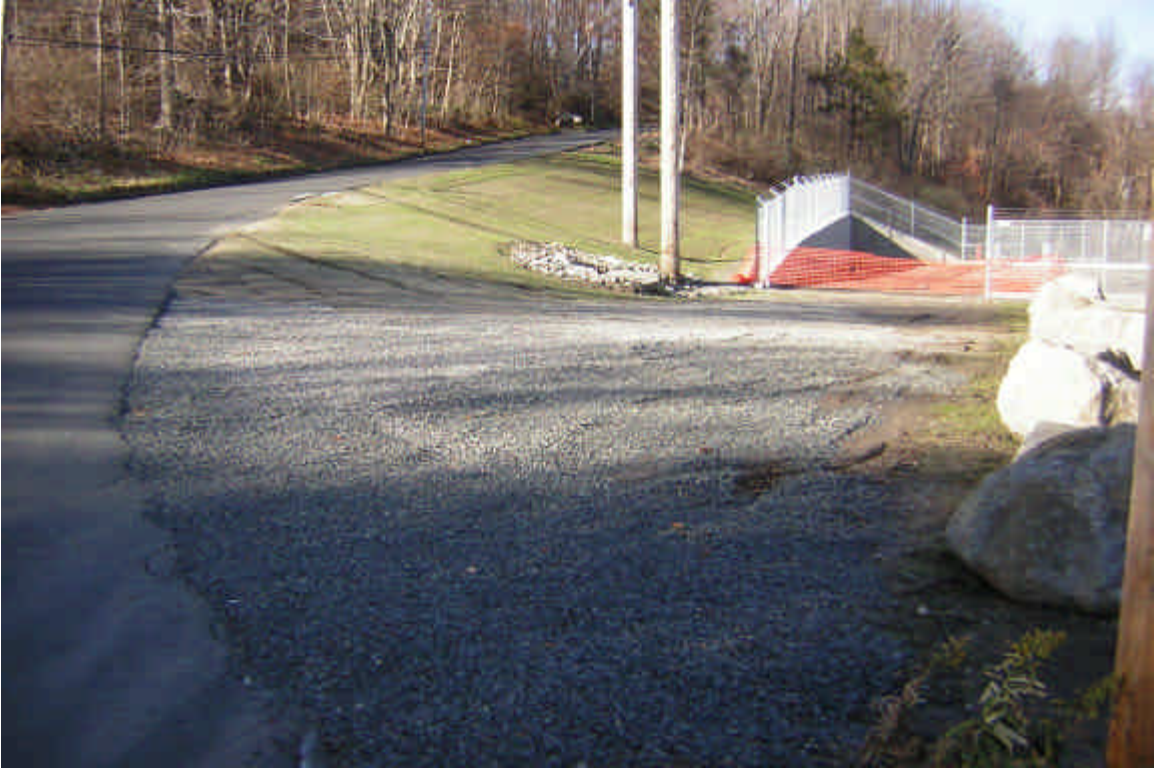
Hoyts Hill Transition Station: Overview of the station yard and the access in from Hoyts Hill Rd. 11/23/05

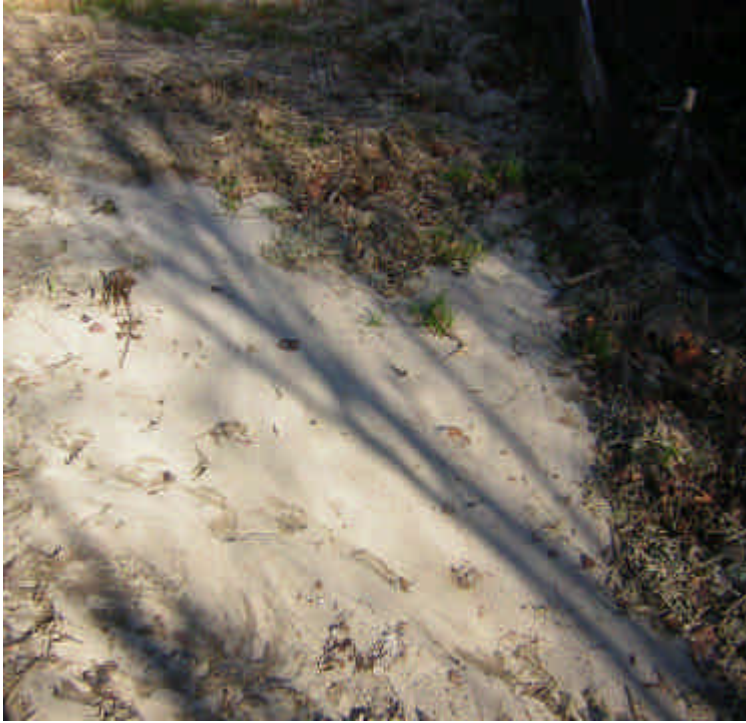
Photo on the left shows accumulated sediment within the yard (contained within the silt fence) due to the erosive gullies or outlet drain. Photo on the right shows one of the outlets with sediment trapped in the stone pad. 11/23/05

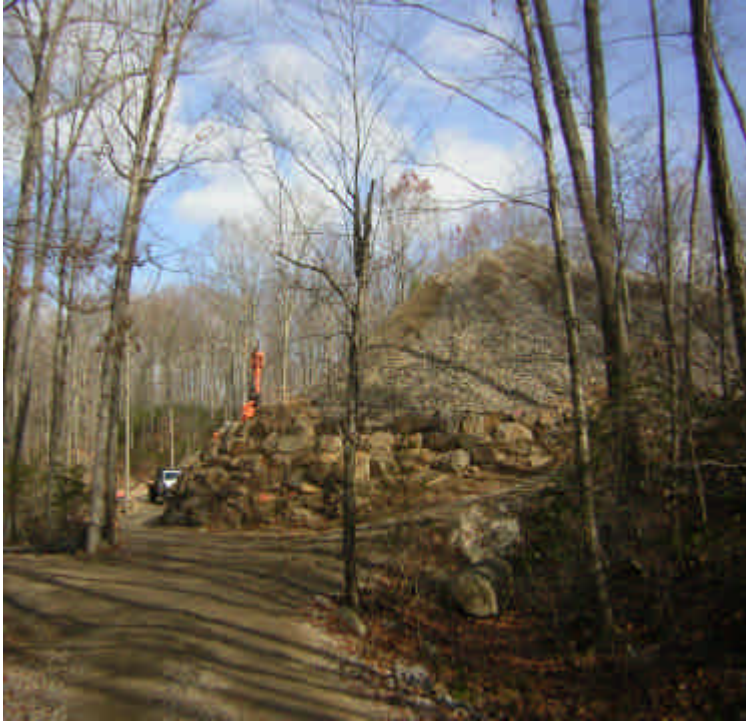
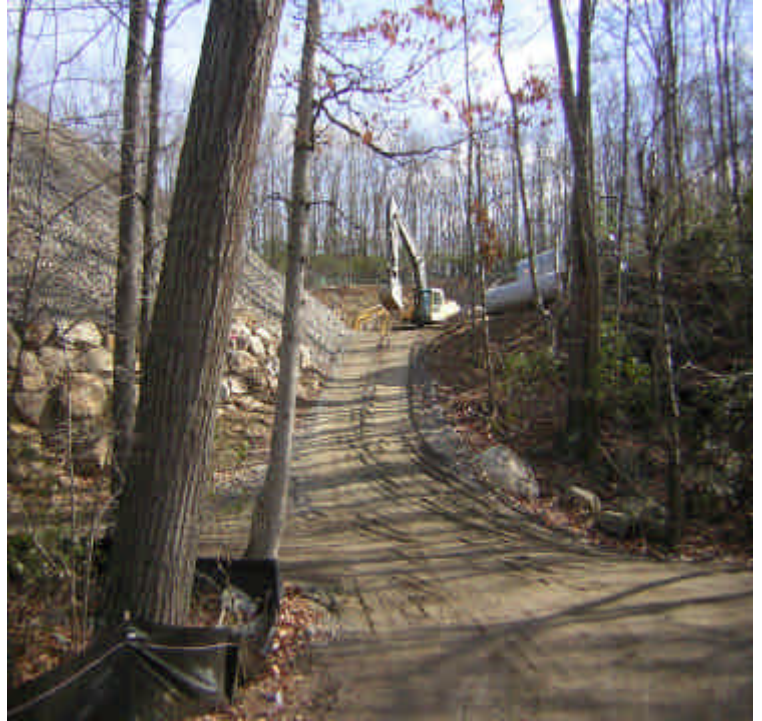
Archers Lane: Both photos show a view of the earthwork ongoing with stone being crushed and stored on site. Trucks are also constantly hauling loads away. 11/23/05

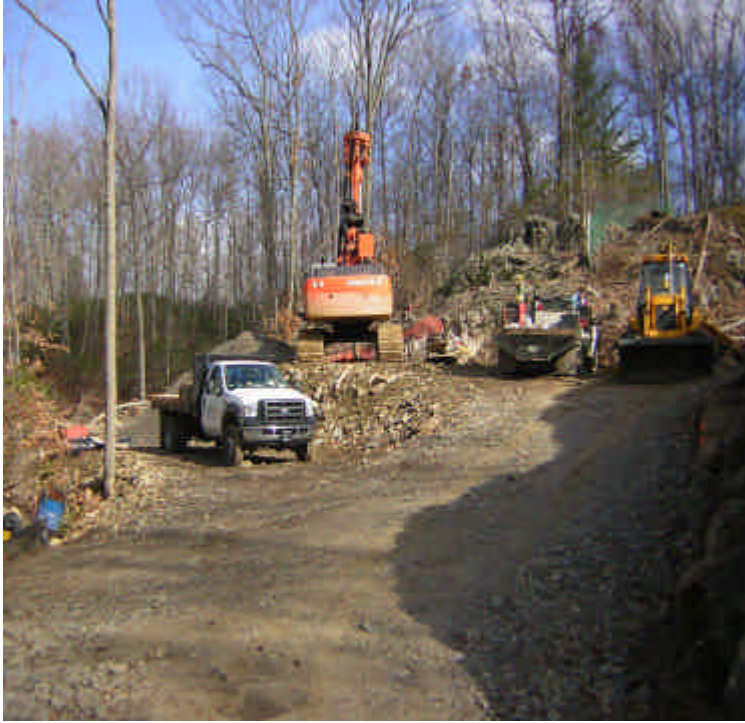
Photo on the left shows another view of the earthwork and the drilling for the new structure. Photo on the right shows the cleared view into Archers Lane from the adjacent ROW. 11/23/05

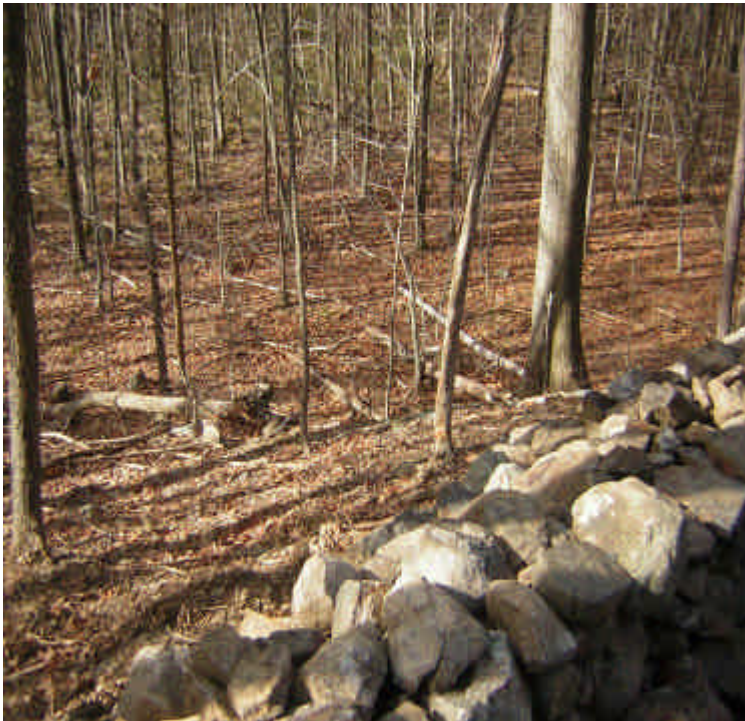
Photo on the left shows the property boundary/stone wall where the wayward material was removed. Photo on the right shows sediment tracking on Diamond Hill Rd. The street has been swept but needs to be done so regularly due to the heavy truck traffic. 11/23/05

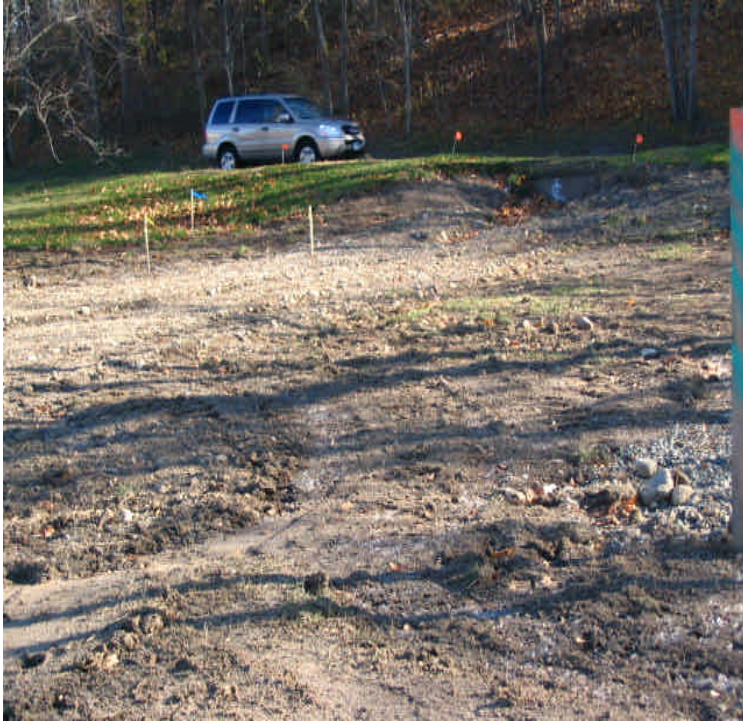
Norwalk Junction: Photo on the left is the view looking towards Rt. 7. Photo on the right is an overview of the site at this time. 11/23/05

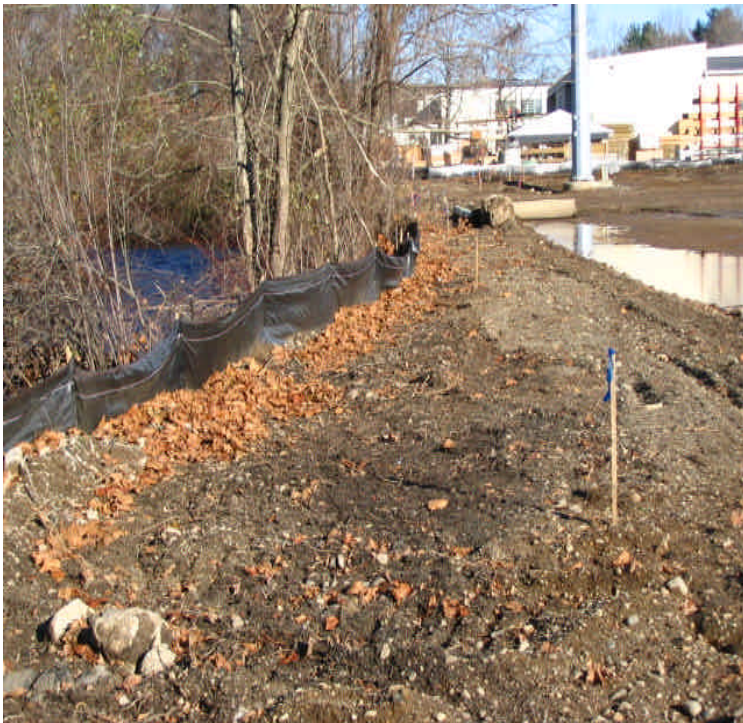
Photo on the left shows the erosion control in place with the river in close proximity with water running clear in this area. Photo on the right shows an area beyond the silt fence which was apparently cleared when brush was removed. This bare soil area should either be restored with mulch or the silt fence needs to encompass it. 11/23/05
